Seaways

The International Journal of The Nautical Institute

Mariners' Alerting and Reporting Scheme

MARS Report No. 282 April 2016

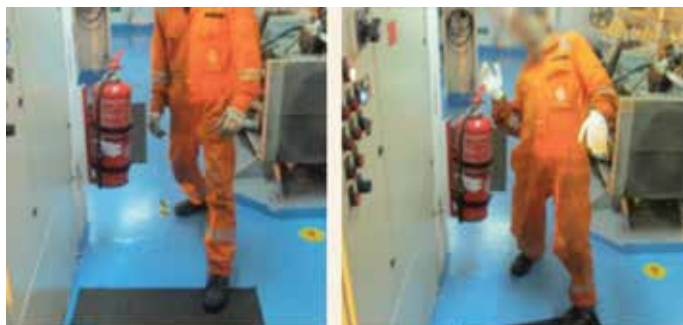
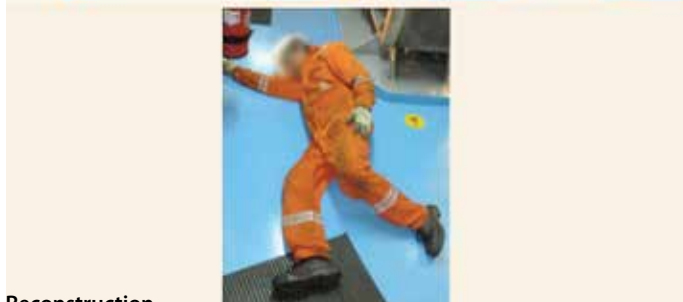
Reconstruction

While an oiler was on his usual rounds and near the air compressor the internal telephone system sounded. He quickly proceeded towards the engine control room to answer the call; as he stepped on the insulation mat in front of the main air compressor breaker panel the mat slipped under foot and he fell. After examination it was determined that his shoulder had become dislocated.

The company investigated the incident and has since removed the mat from service as the underside was worn and not gripping properly. All other mats have been checked for their grip and wear.

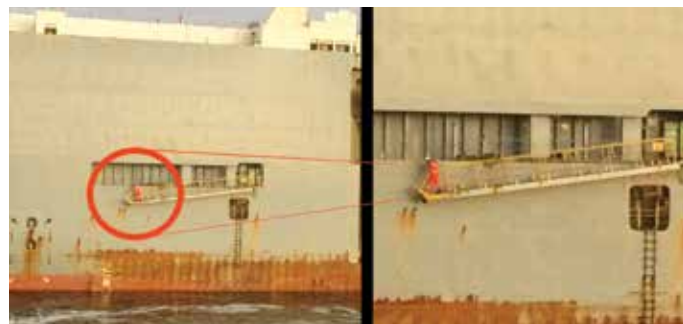
→ The car carrier was leaving berth and the deck crew were at various tasks about the ship, securing lines and bringing in the gangway among other things. One crewman was at work securing the gangway. Working alone approximately seven metres above the water, without a life vest or lifeline, he secured the railing posts prior to bringing the gangway up to its stowed position.

No unwanted consequences were known to be forthcoming – but an unsafe working practice was observed.

- Unsafe working practices can creep into our daily routine by the very fact of their commonplace nature.
- When working over the side one should always wear a life jacket.
- Working alone while over the side virtually guarantees your death if you should fall in the water as no one will know you are in the water.

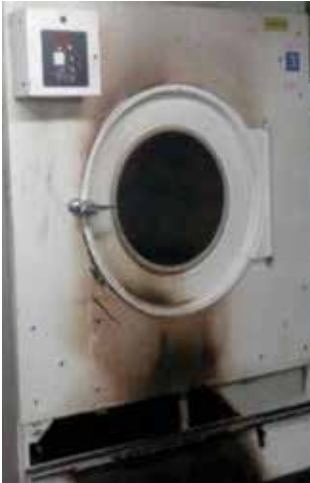
→ A small fire developed in a dryer onboard a cruise ship. The fire was quickly extinguished by the vessel's crew and caused no significant damage. Investigators suspect that a minor spark occurred due to a loose or disconnected wire, igniting lint in the spaces under the dryer and then the rags in the dryer drum.

Subsequently, it was discovered that a built-in fire suppression system, a component of the dryer designed to spray water into the drum in case of fire, had been disabled on all six of the vessel's installed dryers.

- The processes and procedures related to the fire suppression systems were not included in the vessel's maintenance systems.
- Regular inspections and evaluations of this fire suppression equipment did not occur.

- The shared responsibility for inspection and maintenance of the laundry equipment by two sub-departments (galley service technicians and the electrical department) was ambiguous.
- Laundry systems and the normal production of dryer lint create significant fire hazards due to the flammability of the lint.
- Various sources indicate that the majority of dryer fires are caused by spontaneous combustion of residual soils, paint, edible oils, etc. Furthermore, they are also caused by human error or negligence such as leaving dried materials unattended in the dryer; not properly washing, rinsing and extracting clothes; not cooling down dryer loads for ten minutes at ambient temperatures; improper cleaning lint traps; and damaged lint traps.

- Always keep 'safety components' such as automatic temperature controls, timing devices, cool down cycles and fire sensing/smothering devices in top operating condition.
- It may be a good idea to re-evaluate the risks associated with industrial washing and drying equipment on board your vessel.
- Establish clear lines of responsibility for equipment inspections, maintenance and repair.
- Never override safety components.
- Consider the need for additional signage and instructions in the working languages of the ship.

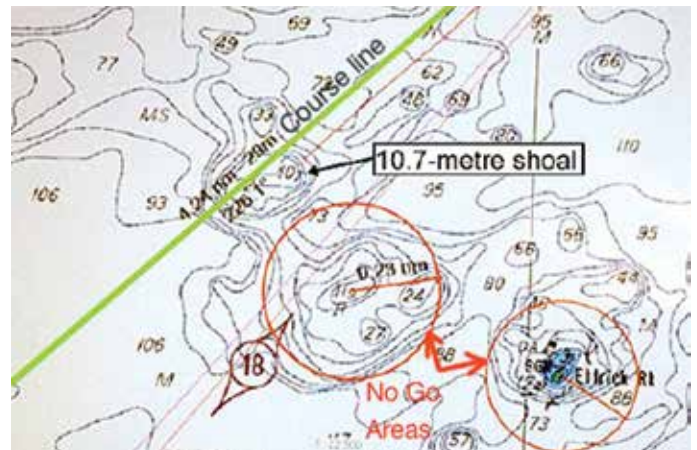
Approximately 10 minutes later, after the Master and pilot had examined the chart in detail, it was confirmed that the vessel was aground on a shoal with a charted depth of 10.7 m approximately 140 m south of the plotted course line. Inexplicably, the pilot had made two no-go zones southeast of the intended course line on his PPU but not the 10.7 m spot much nearer the course line on which they eventually grounded (see chart).

Pilot's PPU screen (10.7m shoal annotated by TSB)

- The vessel's destination unexpectedly changed upon departure, and the new route passed in proximity to a charted 10.7 metre shoal.
- The charted shoal was not detected by the bridge team either while planning the revised route or during monitoring of the vessel's progress.
- The pilot's PPU was not configured with all available route planning and monitoring features to assist in the detection of known hazards.
- The vessel, with a draft of 13.3m, ran aground when it passed over a charted shoal of 10.7m.

- Whenever a plan changes at the last minute, it is worth your while taking a few extra minutes to examine all aspects of the situation.
- Always study the chart in detail and outline any no-go areas in the vicinity of your course line.
- In this case, the Master, pilot and OOW all missed the fact that the vessel was moving into danger, heading toward a shoal that presented less depth than the vessel's draft. All plans should be carefully reviewed, even those made on short notice.

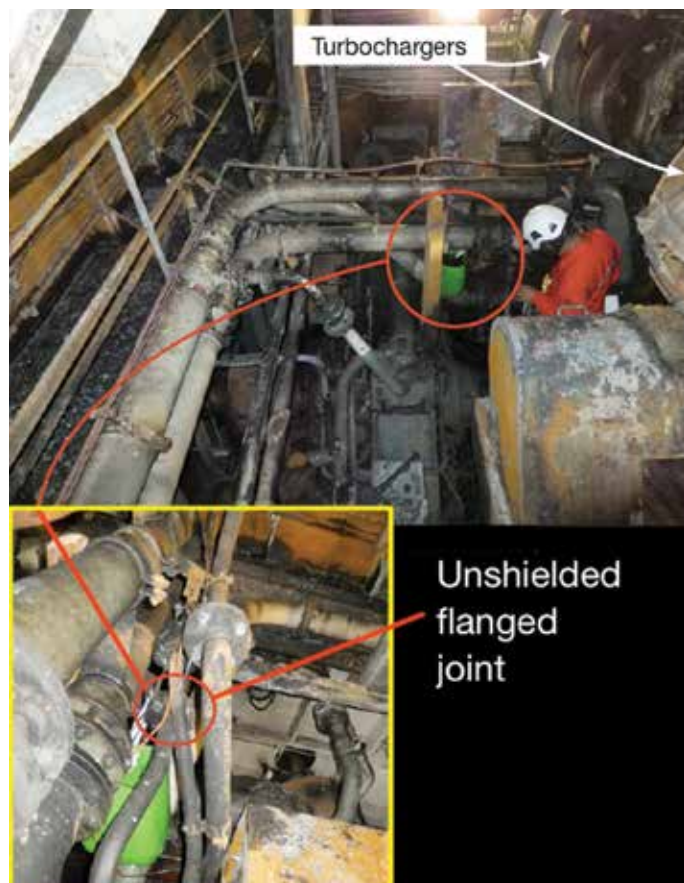
The starboard controllable pitch propeller system stand-by pump was subsequently started to maintain oil circulation. Shortly afterwards, a joint in the system's pipework ruptured, spraying oil onto the hot exhaust uptakes and turbochargers. The oil ignited, causing a significant fire in the main engine room, which was subsequently evacuated. The general emergency alarm was sounded and the passengers were mustered at emergency stations. The ferry berthed safely and the fire was extinguished using the ship's hi-fog system and a fire hose. The passengers and cargo were disembarked normally.

- The back pressure valve in the starboard controllable pitch propeller hydraulic system had jammed shut, causing the oil pressure in the return line from the oil distribution box to rise; a flanged joint in the return line from the oil distribution box was unable to withstand the high pressure that resulted, spraying oil onto hot engine parts.
- The joint that failed was not shielded to prevent a spray of oil in the event of failure. Although SOLAS now requires that, as far as practicable, oil lines should have the minimum of joints, be arranged as far apart from hot surfaces as possible, and be shielded to prevent oil spray onto hot surfaces, these control measures were not required at the time when the ferry was constructed. If an effective joint shield had been fitted, this would have prevented a spray of oil being released onto hot engine parts, thus no fire would have resulted.

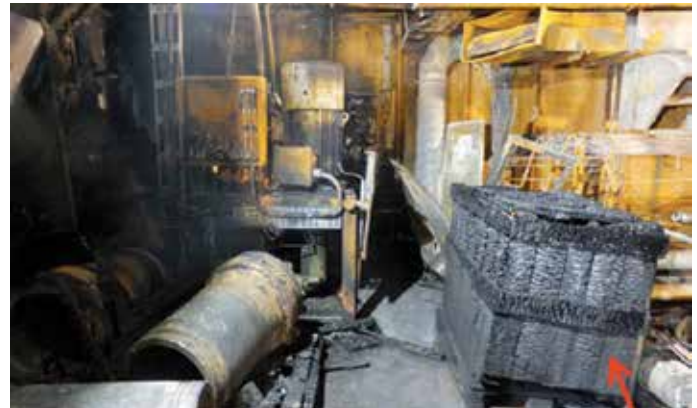
- While the hi-fog system was able to tackle the fire in the immediate vicinity of the two main diesel engines, the fire was able to spread outside of this area. Combustible materials, including wooden packaging, that were located near the source of the fire were a contributing factor to the spread of the fire.

Combustible materials stored near source of the fire

- A specific risk assessment should be done in every engine room to determine the potential for, and protection from, oil under pressure reaching hot surfaces.
- Keep engine rooms as clean and neat as possible with combustible materials stored away from possible sources of ignition.
