# Seaways

June 2016

MARS Report No. 284 June 2016

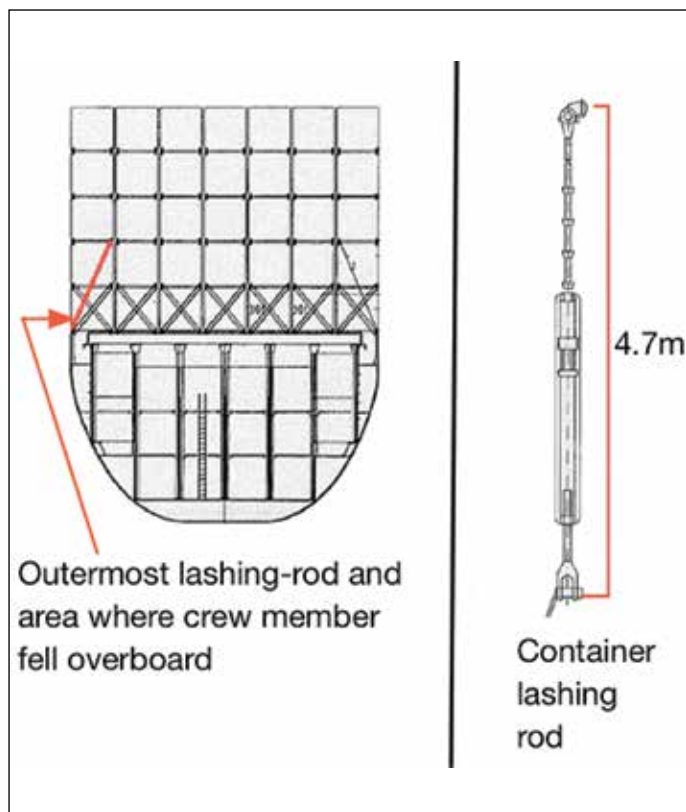
MARS 201627

→ A container ship was underway under pilotage in a confined waterway en route to a berth. Some crew were removing the lashing rods in preparation for discharge once berthed. One of the seamen removed the outermost long lashing rod (4.7m long) and was seen balancing with it upright in his hands. He was briefly in balance, but then both the lashing rod and the seaman went over the side.

Apparently, it was a regular practice on board, although not written down in procedures, to remove the interior lashings before berthing but not the outermost ones. It is unknown why the crew member did not adhere to this practice.

- When working close to the side or at height, always wear a safety harness.
- If there is a risk of falling overboard, wear a lifejacket.
- Unwritten work practices should be formalised into written procedures and the relevant risk assessments carried out to ensure risks are as low as reasonably practicable (ALARP).

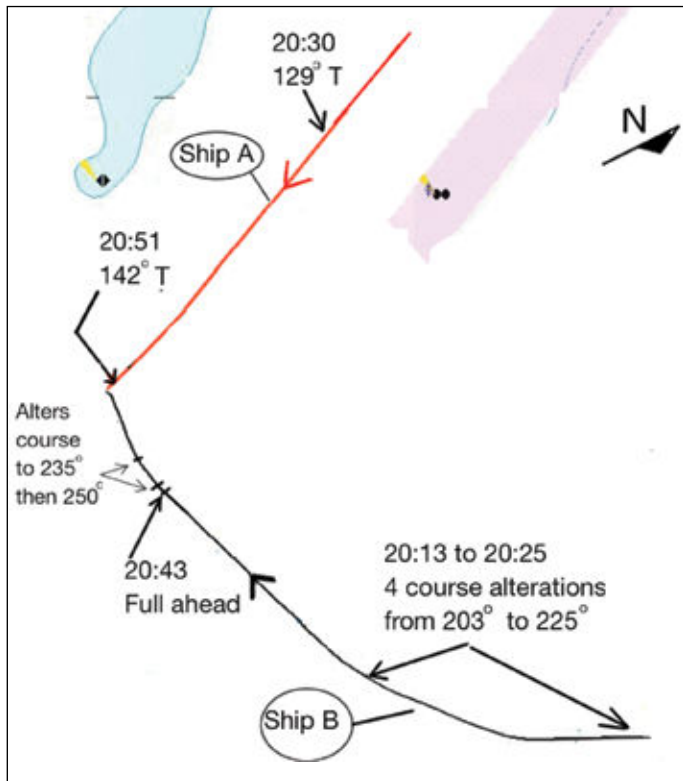
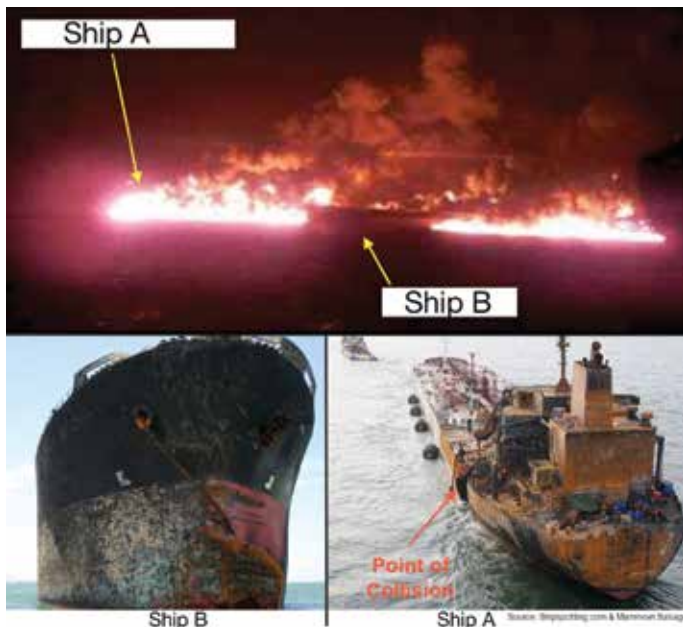
MARS 201628

A massive explosion occurred on Ship A as a cargo tank ruptured and naphtha was spilt and ignited. The ignited spill engulfed the sea surrounding the two vessels.

On Ship A, nine crew members were killed and other crew members injured. Three crew members were injured on board Ship B. Both vessels incurred substantial fire and structural damage as a result of the collision.

- Both vessels were proceeding at full speed at the time of collision, yet one of the safest of time-proven tactics is to slow down when unsure of the developing situation or of the intentions of the opposite party.
- Keep the bridge clear of chit chat and business unrelated to navigating the ship when in high risk areas, high traffic areas or at all other times when maximum concentration is needed.
- Course alterations should be as bold as possible so as to make your intentions known to the other vessels.
- When two ships in your vicinity collide and explode, do your best to stay safe but also render what assistance you can to the fellow mariners involved. Do not sail away as if nothing had happened.

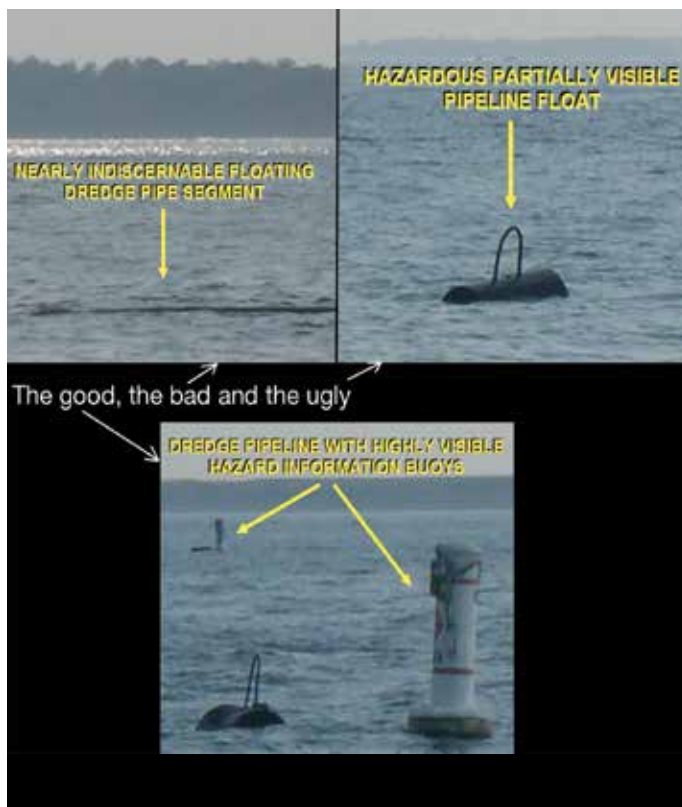
## MARS 201630

➔ Often, dredgers and dredging operations use floating pipes as a means of discharging collected silt and sand. Some dredge discharge pipes are made of high-density polyethylene. Although they are generally buoyant and float, they do so in a mostly submerged manner.

Accidents in the past have been caused by unmarked or improperly marked segments of dredge piping strings and equipment, or unretrieved piping near busy waterways and unmarked piping. Unwanted consequences, especially to small craft, have included extensive damage to hulls, shafting, rudders and keels but also injury and death to crew and passengers.

- Commercial entities performing dredging in waterways should ensure all components of pipelines are properly marked and accounted for regardless of the recreational boating season and locations where dredging is taking place.
- Proper lights and shapes should be displayed on floating gear in accordance with the applicable regulations.
- Commercial ship traffic and pleasure craft should keep a sharp lookout when navigating in areas where dredging operations are taking place.
